Abstract

Heated Exhaust Gas Oxygen Sensors are used to detect the emissions of the everyday vehicle. Applying a voltage to these sensors simulates the conditions that the sensor is under when in a vehicle. Experiments show that when a voltage is applied for a long enough time, blackening occurs around the electrodes. By performing voltage treatments, it is possible to define the conditions that cause blackening. It is also possible to see the changes in the structure of the Yttria Stabilized Zirconia (YSZ) by cutting the sensor and looking at it under a Scanning Electron Microscope. Looking at the cut sensor under an optical microscope allows for the design of the sensor to be examined and measurements to be taken.

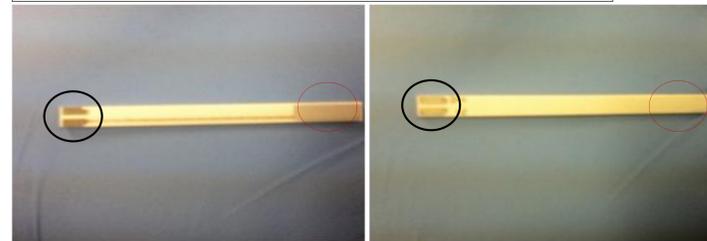
Figure 1: HEGO Sensor. Sensor Side and Heater Side. Blackening occurs in the area circled in red.

Figure 1 shows the sensor. The red circle is where the sensor heats up (fraction 8). The black circle is where the sensor is placed into the housing (fraction 1). These two fractions were compared in using the Zeta 3D microscope. Using this microscope enabled us to measure the changing hole size, as well as see the sensor better. Figure 2 shows the images of sample 6 using this microscope. The picture to the left is fraction 1, where the picture to the right is fraction 8, where the voltage and heat are applied. Showing these pictures side-by-side enables the changing hole size to easily be seen as well as the orientation of the electrodes to be determined. In fraction 1, there are two platinum heater electrodes, seen on the left side of the hole. When looking at fraction 8, there are four platinum heater electrodes. Sample 6 was the first of two blackened samples (samples 6 & 7). The blackening is the discoloration seen in the picture on the right. Figure 3 shows the raw sample. There is no noticeable difference in size of the hole, and there is no discoloration from one fraction to another. Figure 4 shows the Scanning Electron Microscope (SEM) images of Sample 6. This compares the structure of the sample. The image on the left shows fraction 6, which is not blackened. The image on the right shows the blackened fraction 8. Figure 5 shows the X-Ray Diffraction (XRD) data comparing Sample 6 to the Raw Sample. The counts of Yttria Stabilized Zirconia (YSZ) are significantly less in the blackened sample.

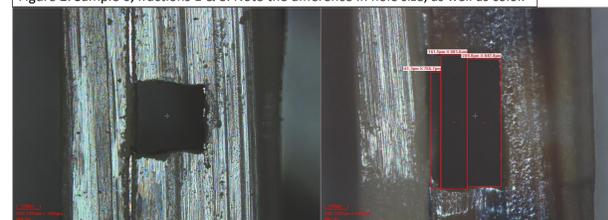
Figure 2: Sample 6, fractions 1 & 8. Note the difference in hole size, as well as color.

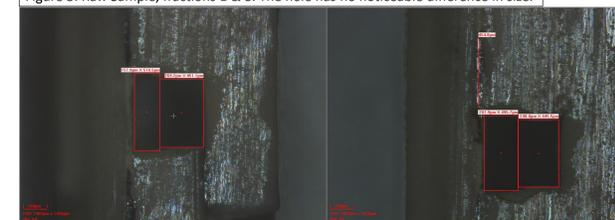
Figure 3: Raw Sample, fractions 1 & 8. The hole has no noticeable difference in size.

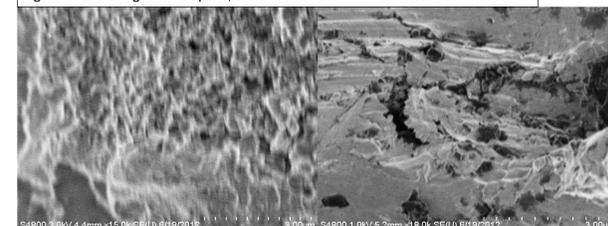
Figure 4: SEM images of Sample 6, fractions 6 & 8. Note the difference in structure.

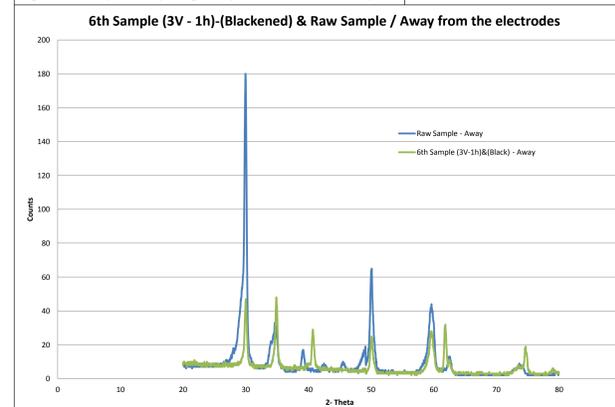
Figure 6: XRD plot comparing sample 6 with the raw sample.
